BALL HOME INSPECTION

TREC REI 7-6

1234 Main Street
Ft Worth TX 76244

PROPERTY INSPECTION REPORT FORM

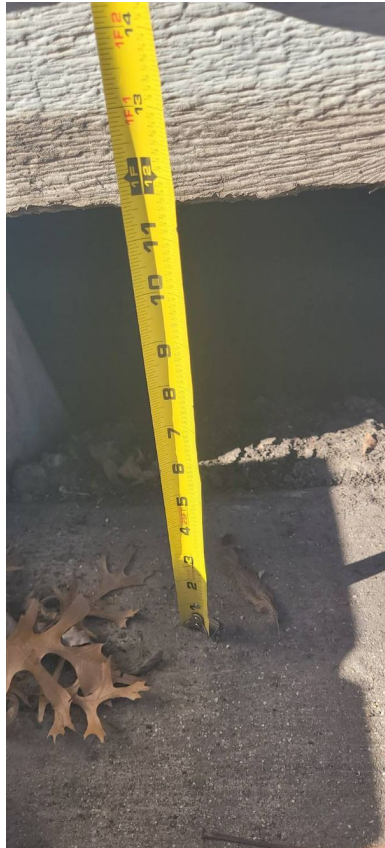
1: Improper Construction Practices

Improper or sub-standard construction practices were noted at the foundation wall or slabs/piers. Recommend a structural engineer evaluate and advise on how to bring the construction up to standards.

Recommendation: Contact a qualified structural engineer.

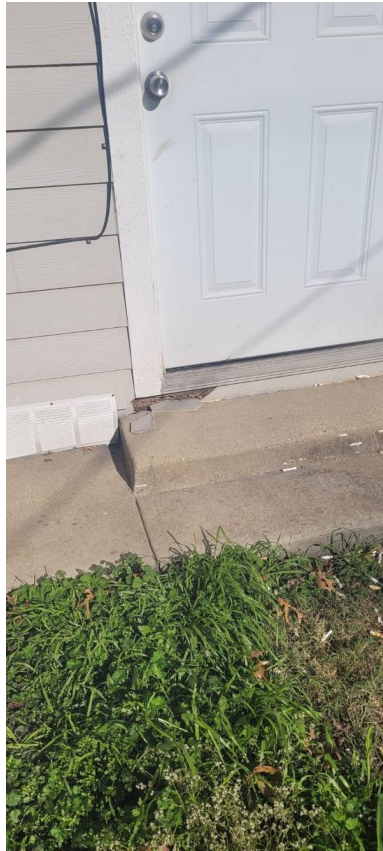
3: Ventilation

The crawl space was not vented properly. There should be a vent on each the wall with a total of 1sq foot of vent for every 500 Sq ft of space. This is to prevent moisture build up that would cause wood rot and mold.

Recommendation: Contact a qualified professional.

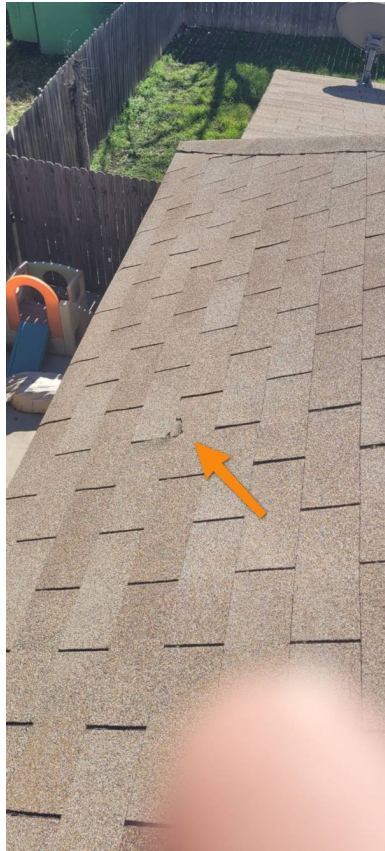
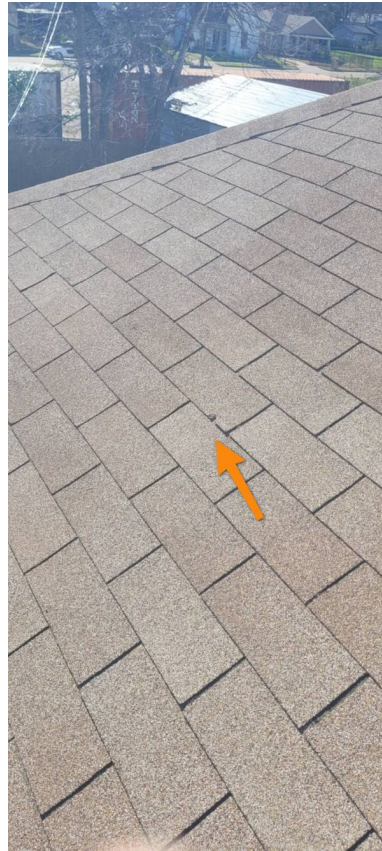
1: Damaged Coverings

Roof coverings exhibited general damage that could affect performance. Recommend a qualified roofer evaluate and repair.

Shingles lifting

Recommendation: Contact a qualified roofing professional.

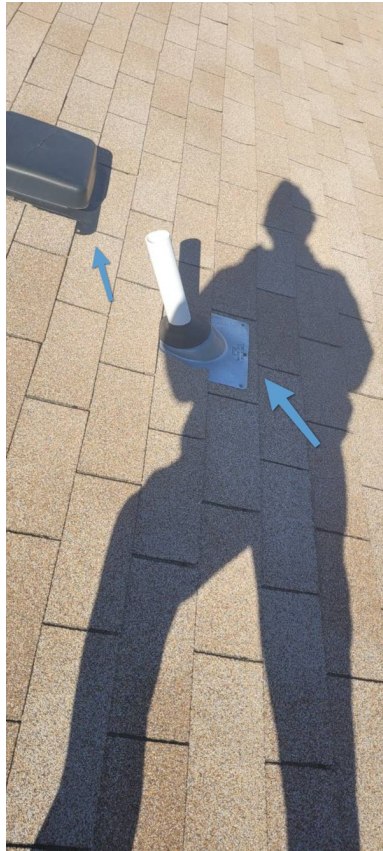
Under-driven or exposed nails were found in one or more roof coverings. Recommend a qualified roofer evaluate and repair.

Recommendation: Contact a qualified roofing professional.

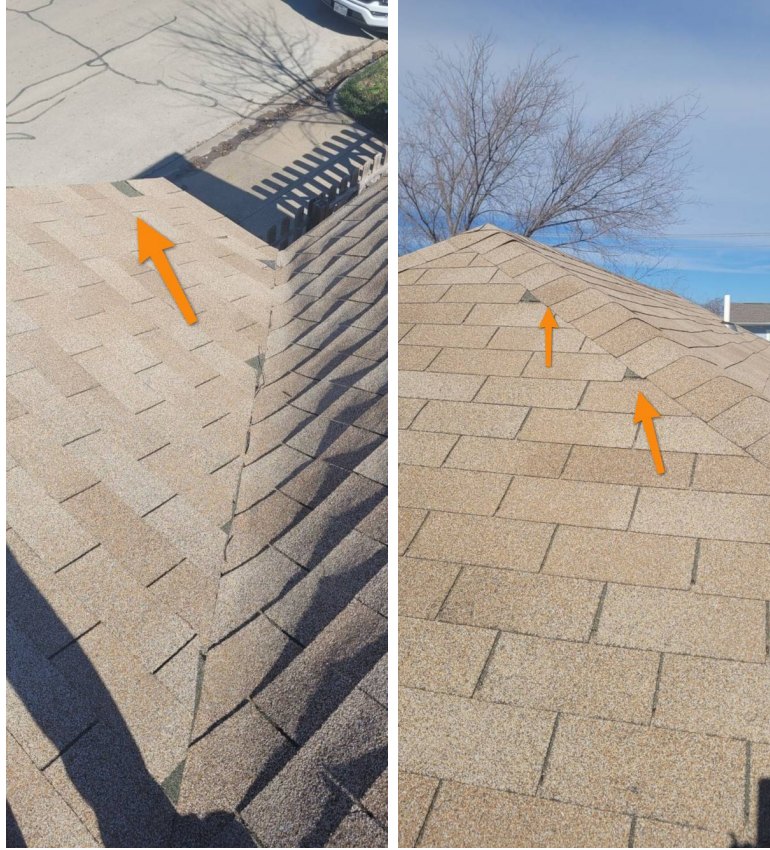
3: Shingles Missing

Observed areas that appeared to be missing sufficient coverings. Recommend qualified roofing contractor evaluate & repair.

Recommendation: Contact a qualified roofing professional.

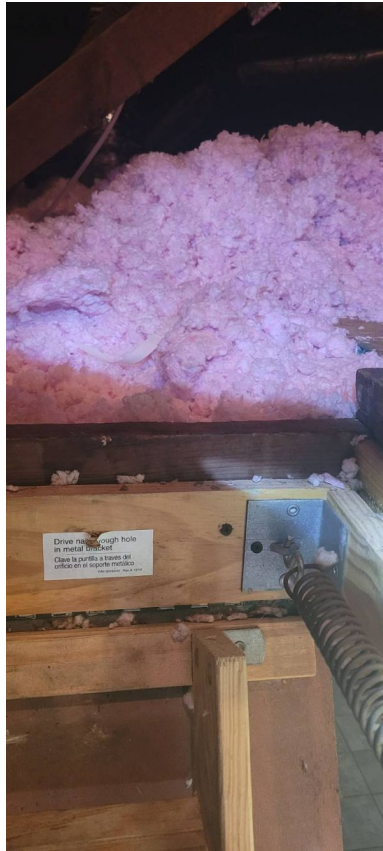
Limited view of attic. It was inspected from platform. Area above garage and front porch were also inspected. Walking through the attic would mess up insulation and there is a risk of causing damage to ceiling.

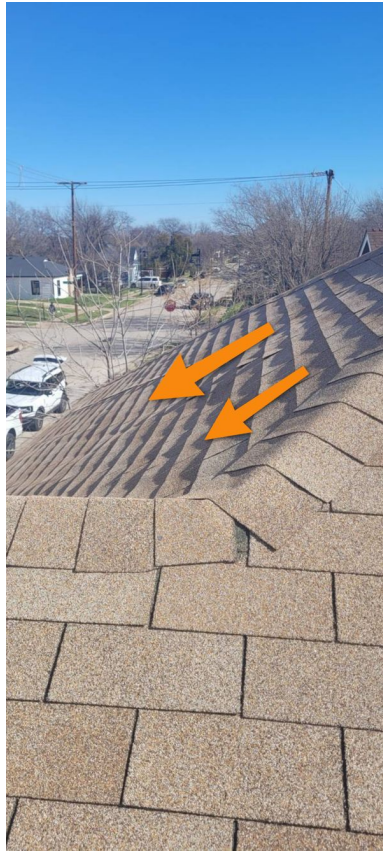
Areas of the roof sagged, indicating sheathing or rafter deficiencies. This could be an indication of foundation movement. Recommend evaluation and repair.

Recommendation: Contact a qualified professional.

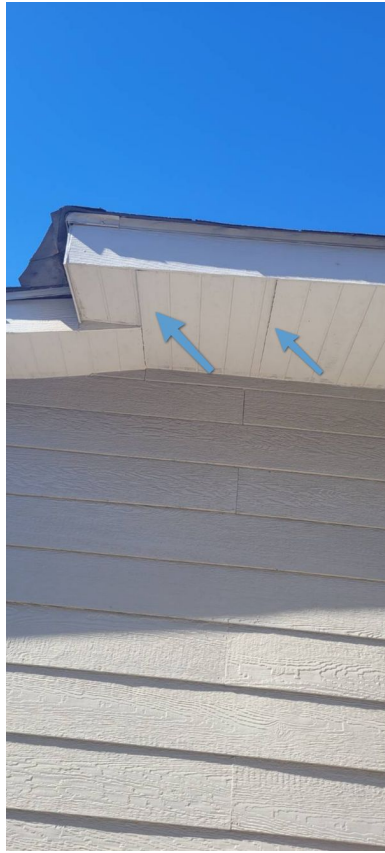
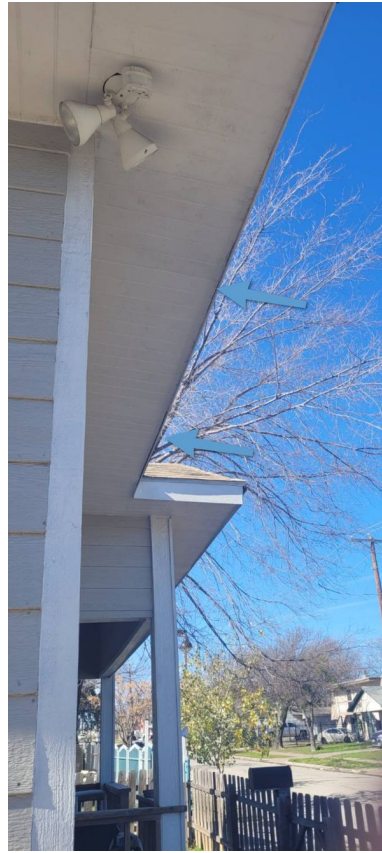
2: Eaves missing calking

Several areas of the eaves are missing caulking. Recommend having caulking replaced. The caulking prevents water and pests from entering home creating more damage.

Recommendation: Contact a handyman or DIY project

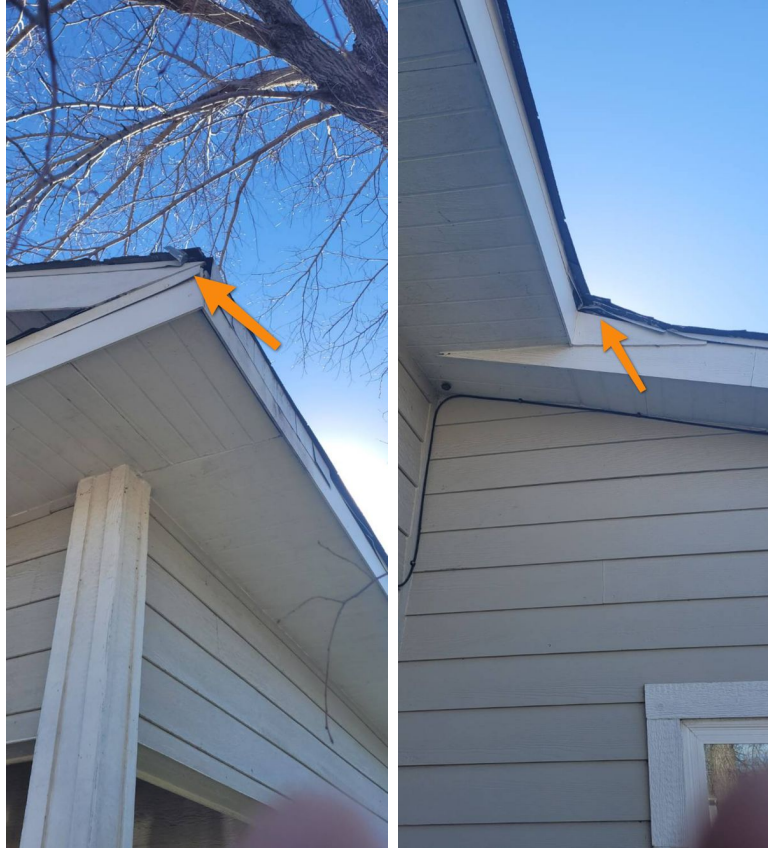
4: Damage Drip Edge

Eaves have multiple areas of damaged or improperly installed

Recommendation: Contact a qualified roofing professional.

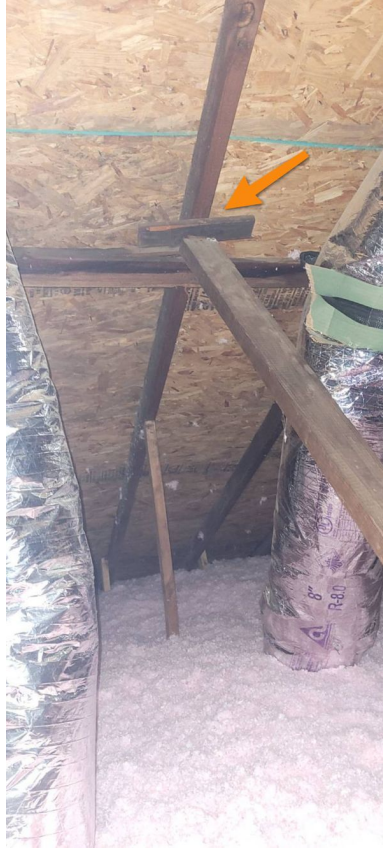
5: Rafters Lack Proper Support

Rafters in attic lack proper support. This was done at time home was built and appears to still be supporting the roof. Recommend evaluating and repair as required.

Recommendation: Contact a qualified carpenter.

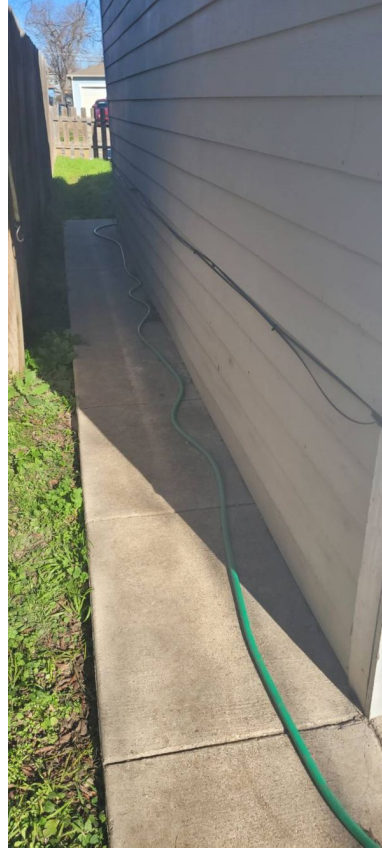
Siding should be kept a minimum of one half inch from ground to prevent water from wicking up into wood causing wood to rot.

Recommendation: Contact a qualified carpenter.

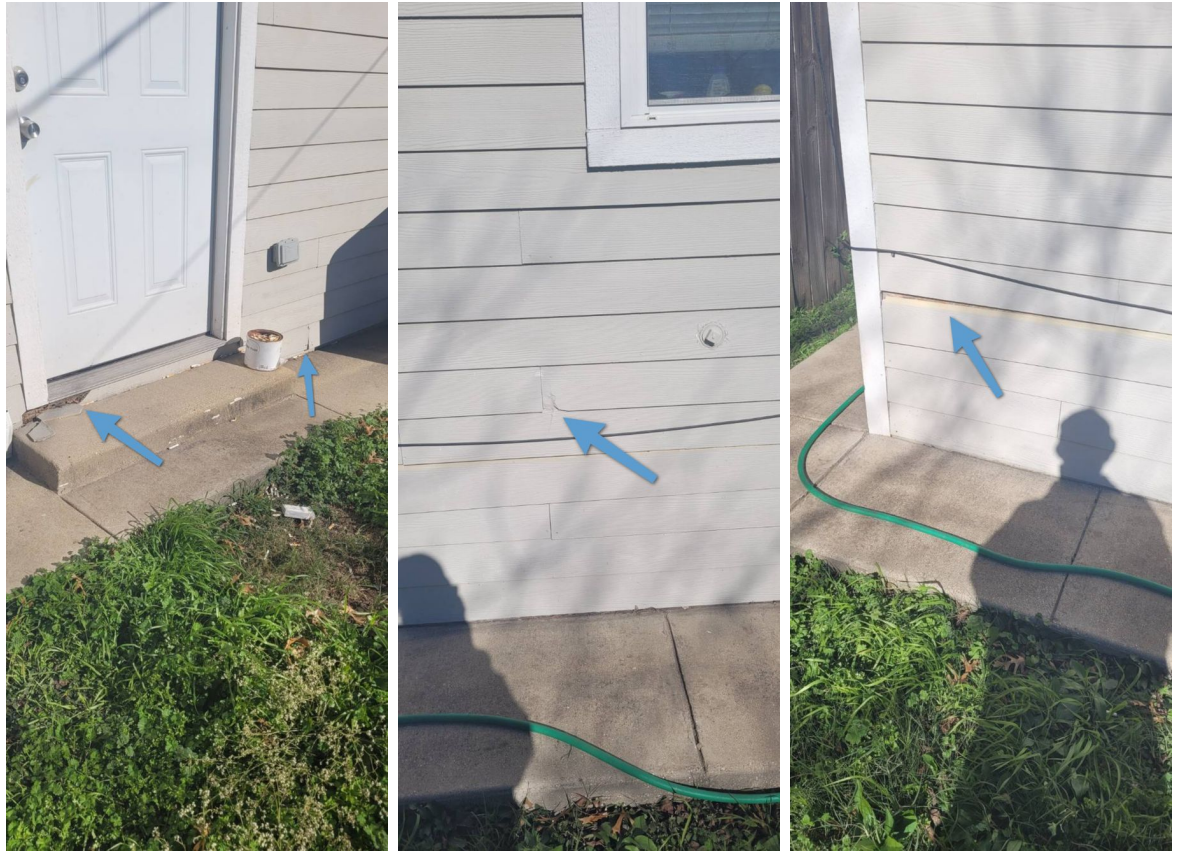
4: Siding damage

Siding shows signs of damage recommend replacement

Siding loose

Recommendation: Contact a handyman or DIY project

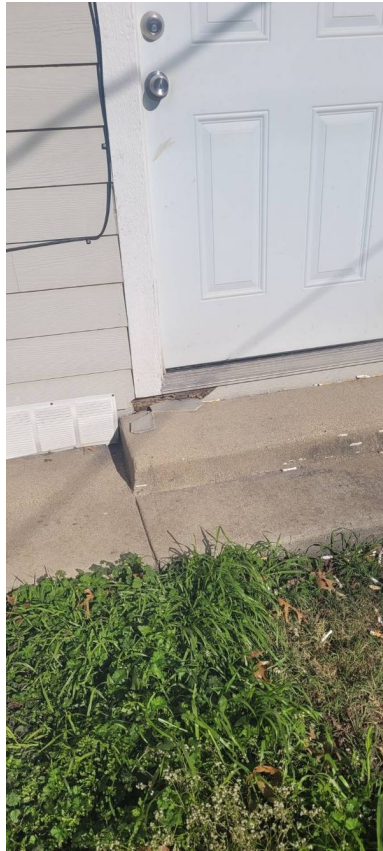
5: Signs of Rot

Evidence of wrought deteriorating. Recommend evaluation and repair as required.

Recommendation: Contact a qualified professional.

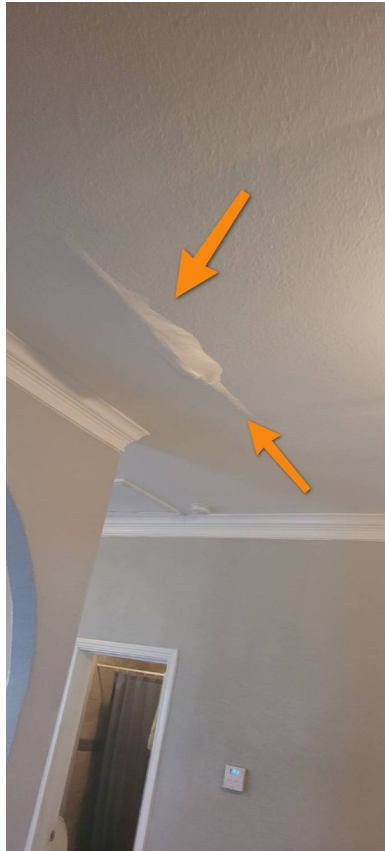
1: Ceiling - Recent Roof Leak Damage

Stains on the ceiling appear to be the result of roof leaks or from AC. The source of leakage should be identified and corrected.

Recommendation: Contact a qualified roofing professional.

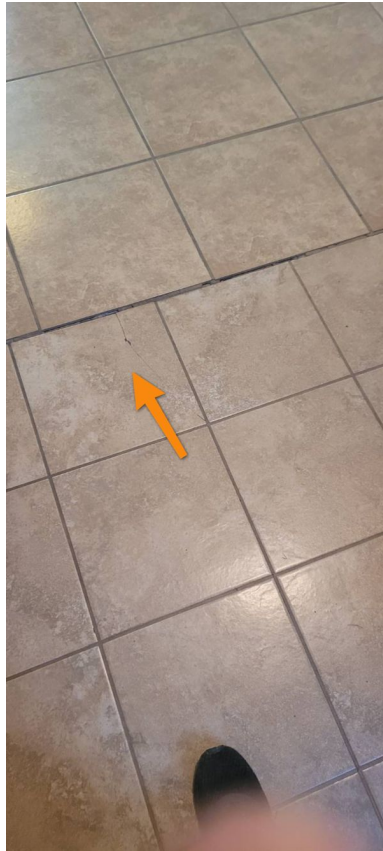
2: Flooring - Tiles Loose

Loose tiles are present. Recommend re-attach and seal.

Recommendation: Contact a qualified professional.

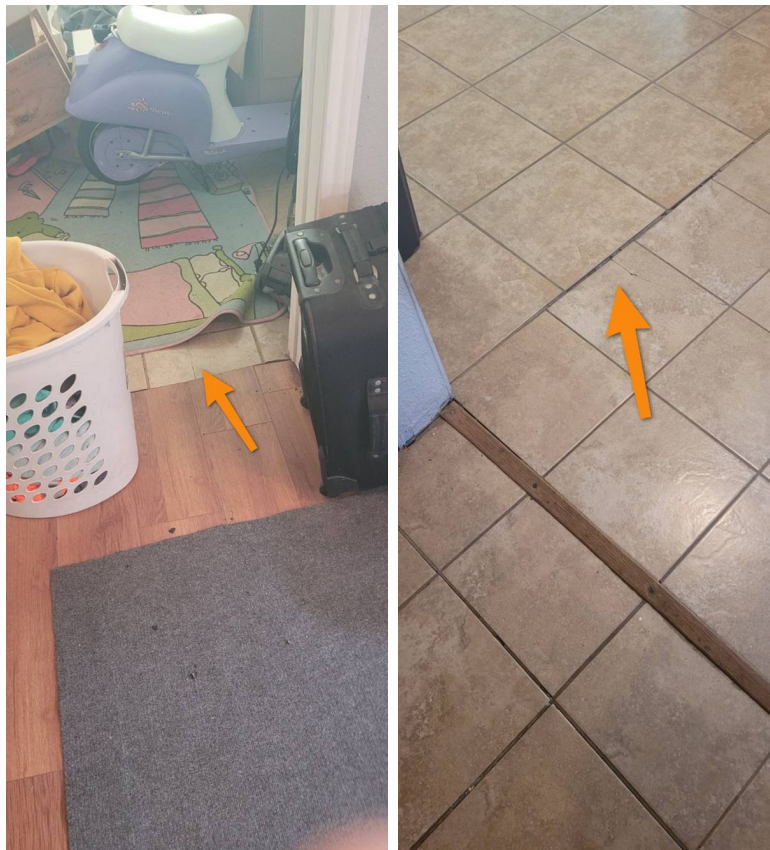
Sections of the floor are spongy which could be indication of rot and could be a hazard should someone step on it and fall through. Recommend evaluation and repair as required.

Recommendation: Contact a qualified professional.

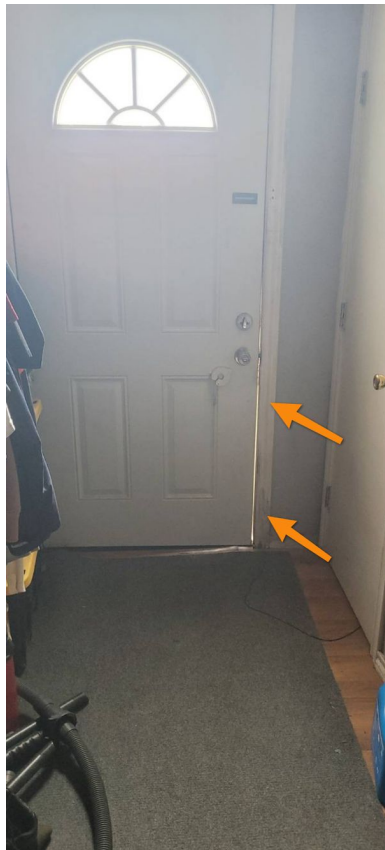
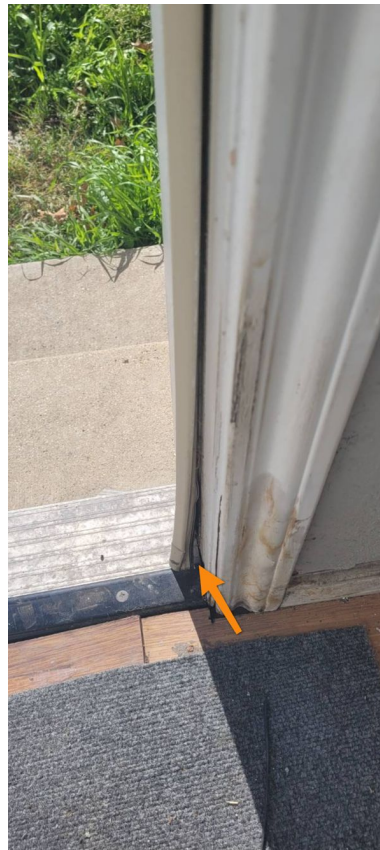
1: Exterior Door Seal Damaged

Damaged door seal could result in energy loss, creating gaps allowing energy loss. Recommend having door evaluated and repaired as required.

Recommendation: Contact a qualified door repair/installation contractor.

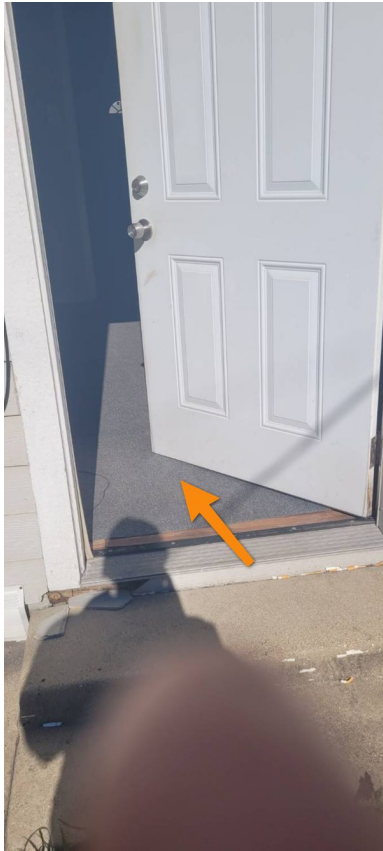
3: Door won't fully open

Back door hits floor when about halfway open. Could be due to foundation movement. Recommend every and repair as required.

Recommendation: Contact a qualified professional.

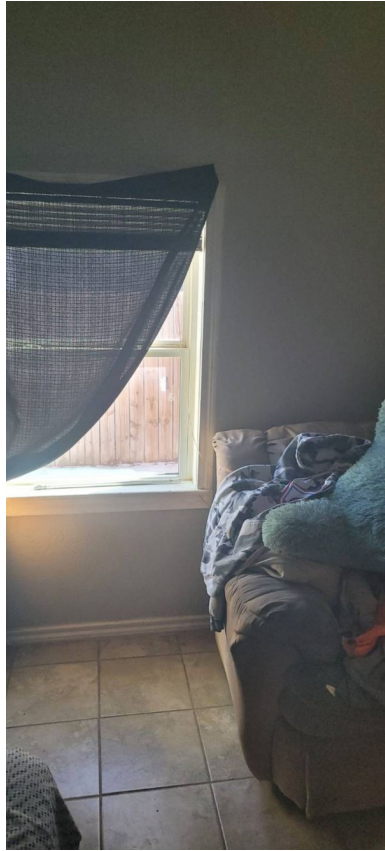
One or more windows failed to operate correctly. Recommend having windows evaluated and repaired as required.

Recommendation: Contact a qualified window repair/installation contractor.

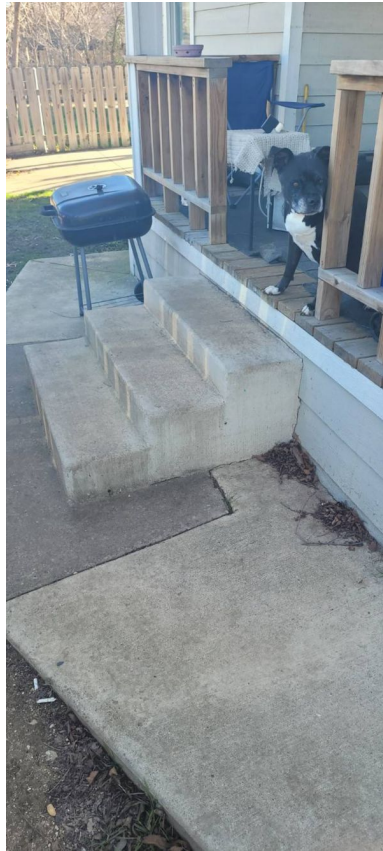
1: Handrail Missing

Staircase had no handrails. This is a safety hazard. Recommend a qualified handyman install a handrail.

Recommendation: Contact a qualified handyman.

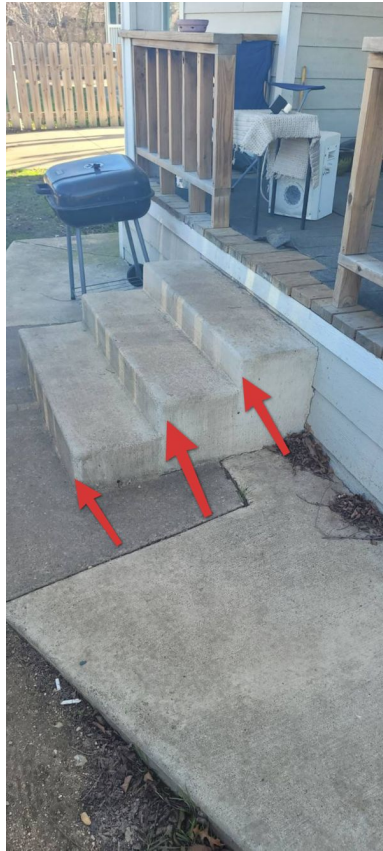
3: Steps uneven

Stair risers are not equally spaced. This can cause a tripping hazard. Recommended repair as needed.

Recommendation: Contact a qualified professional.

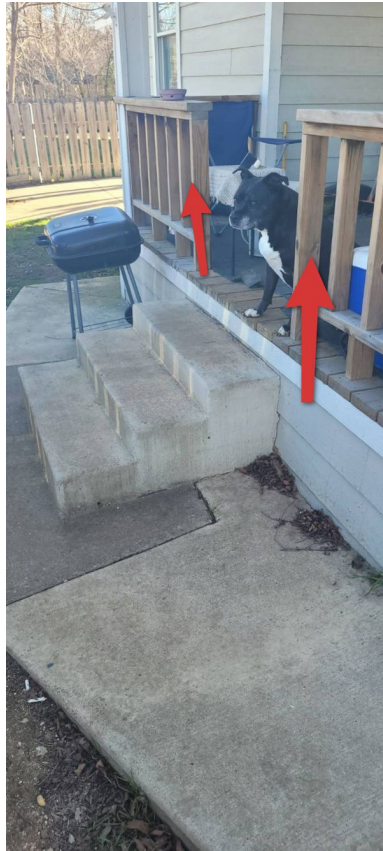
1: Loose handrail

Handrail on porch at top of stairs is loose. Should someone lean on railing or pull on it. The railing would not hold. Recommend securing handrail.

Recommendation: Contact a qualified professional.

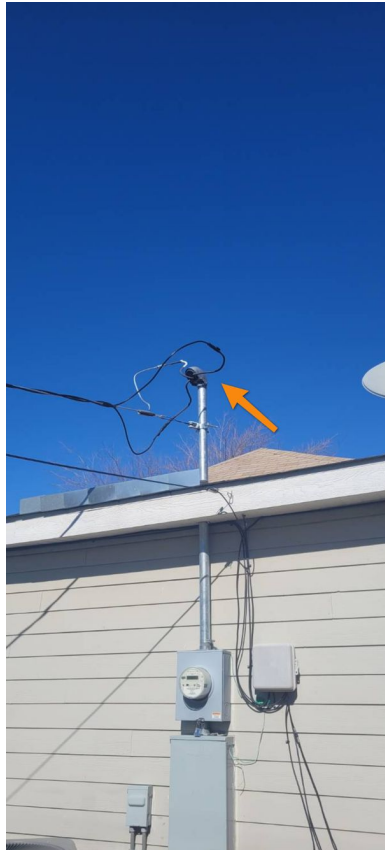
Services wires coming into home should have a loop. This is to prevent water running down into the breaker panel. Recommend having qualified electrician evaluate and repair.

Recommendation: Contact a qualified electrical contractor.

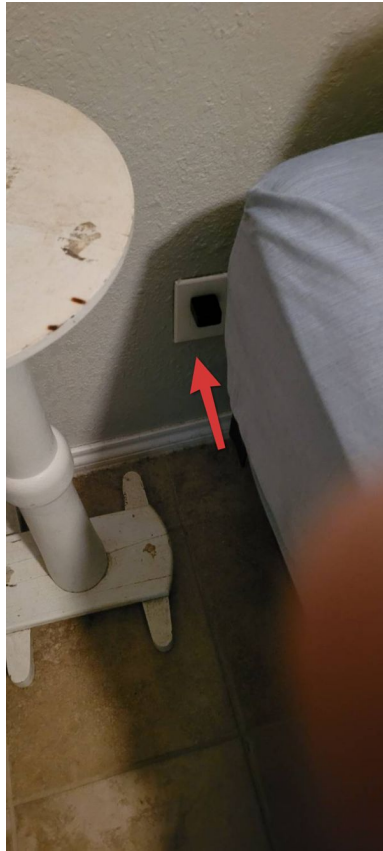
3: Loose outlet

One one or more electrical outlets found to be loose recommend these being secured to prevent electrical shock.

Recommendation: Contact a qualified professional.

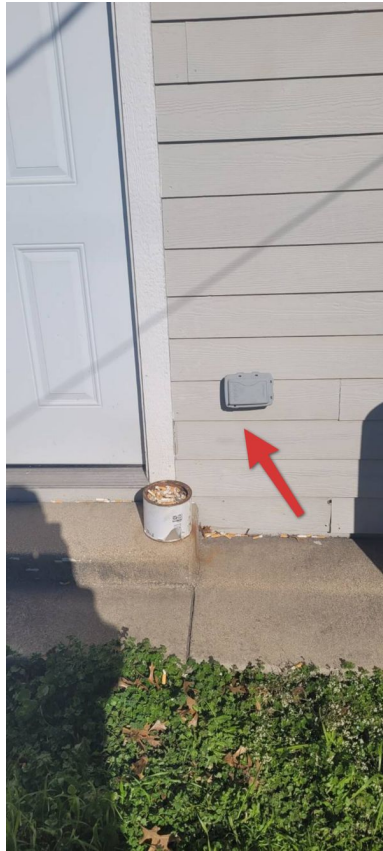
5: Missing tsci

Outside at the outlet has no gsci protection recommend qualified electrician install GFCI to prevent shot

Recommendation: Contact a qualified electrical contractor.

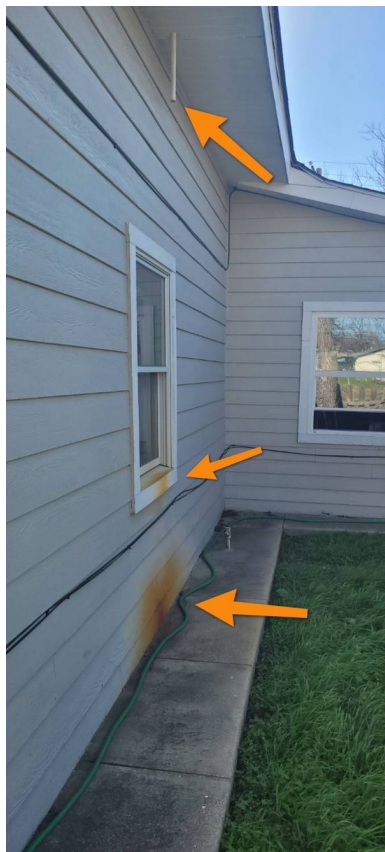
2: Secondary condensation

Secondary condensation drain shows evidence of water coming out indicating the primary dream may be clogged. This is possible from previous time but could not verify. Recommend evaluation and repair as required.

Rusted

Recommendation: Contact a qualified professional.

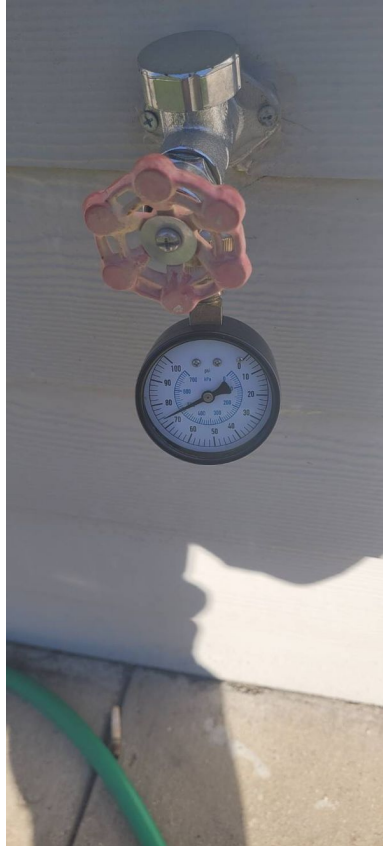
Static pressured was measured at 60 psi

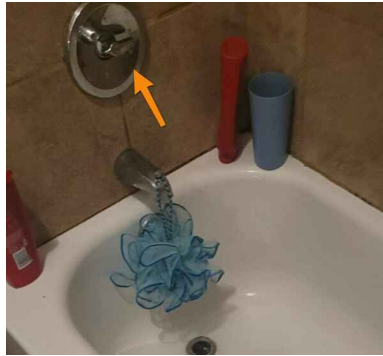
- ☒ ☒ ☐ ☒ **B. Drains, Wastes, and Vents**
Type of Drain Piping Material: PVC
Crawl Space Plumbing:
 Not all plumbing in crawl space could be inspected due to limited access to crawl space.

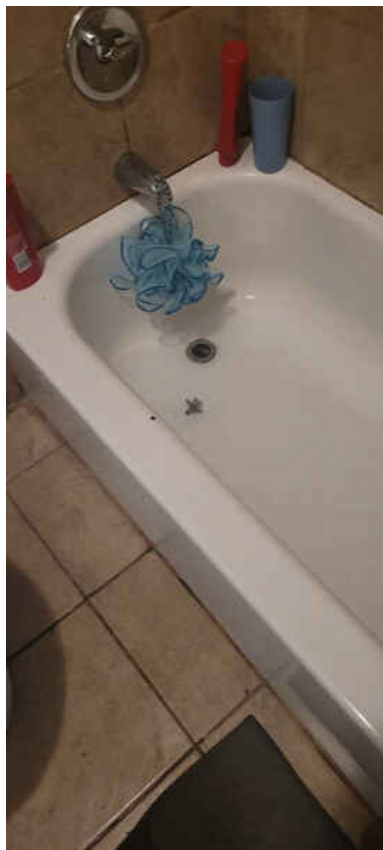
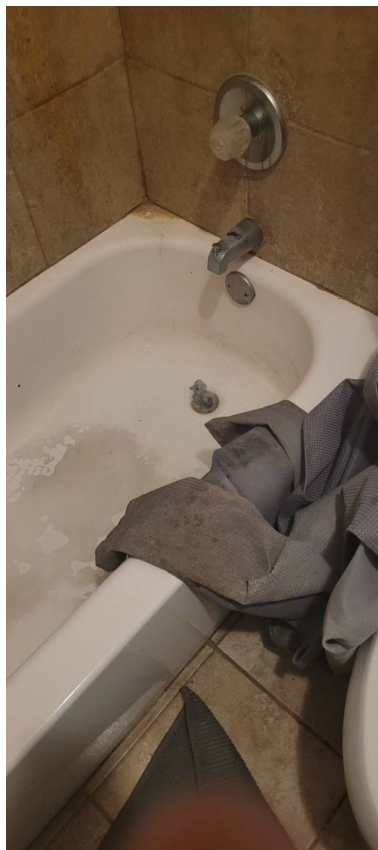
1: Poor/Slow Drainage

Poor/slow drainage was observed at time of inspection. Recommend a qualified plumber evaluate and repair.

Recommendation: Contact a qualified plumbing contractor.

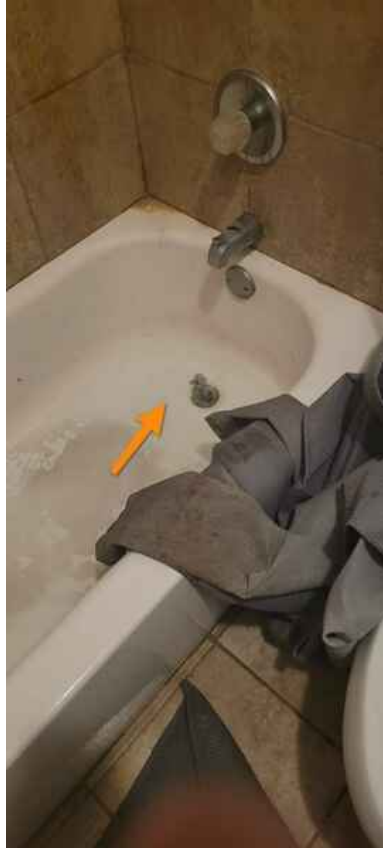
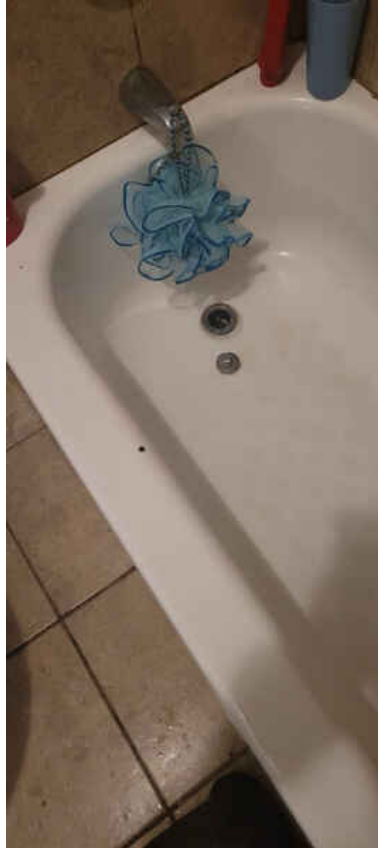
Drain stop does not perform correctly. Recommend evaluation and repair

Recommendation: Contact a qualified plumbing contractor.

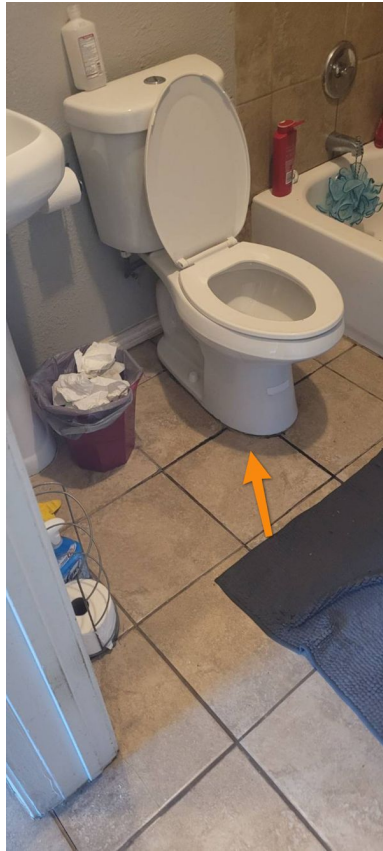
3: Leaking toilet

The toilet was observed leaking water when flushed. This is probably a bad wax seal. Recommend evaluation and repair as required.

Recommendation: Contact a qualified professional.

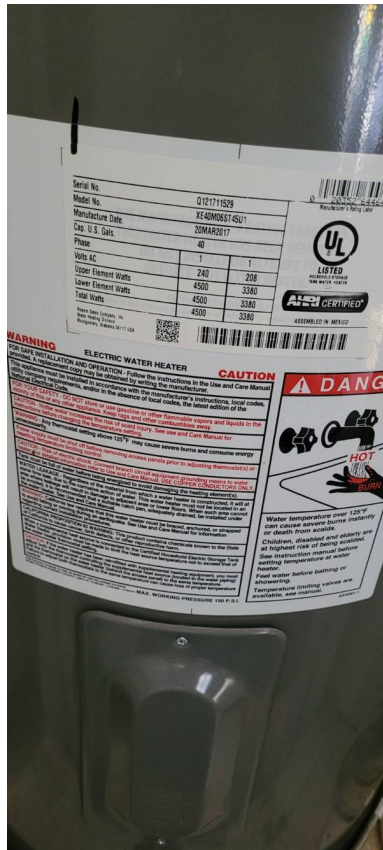
Water Heater was inspected. No defects were noted at this time.

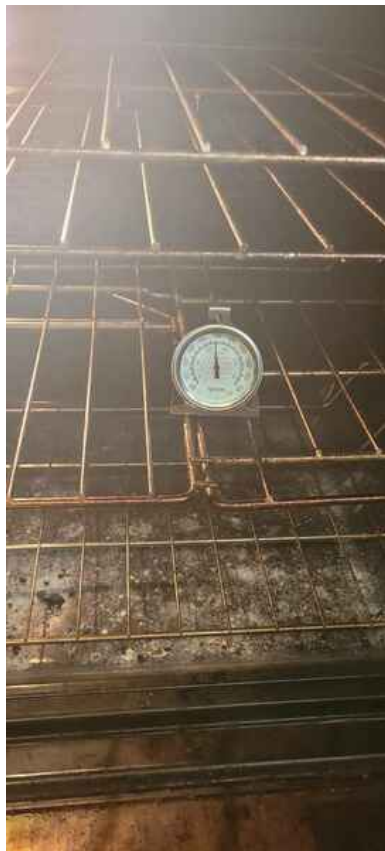
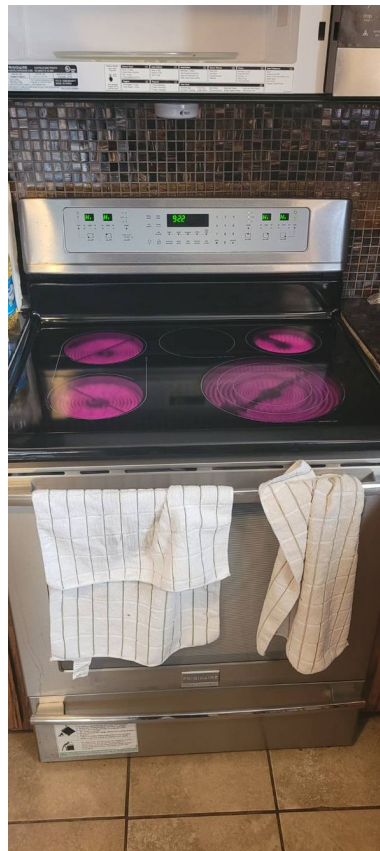
Stove and Oven were tested and no operational defects were noted at this time.

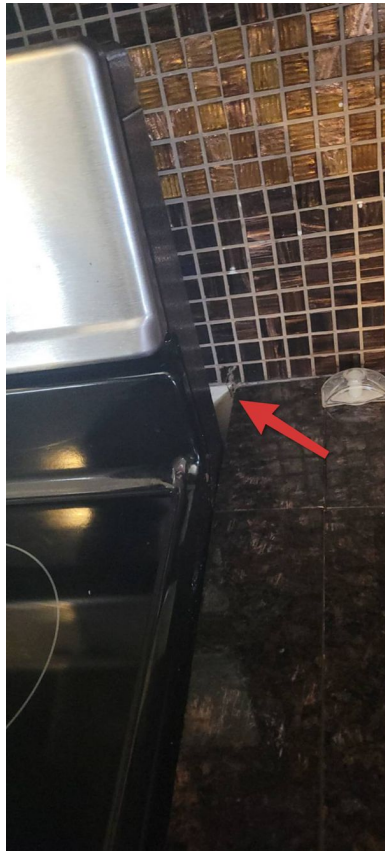
No anti tip device installed. This poses a safety hazard to children. Recommend a qualified contractor secure range so it can't tip.

Recommendation: Contact a qualified handyman.

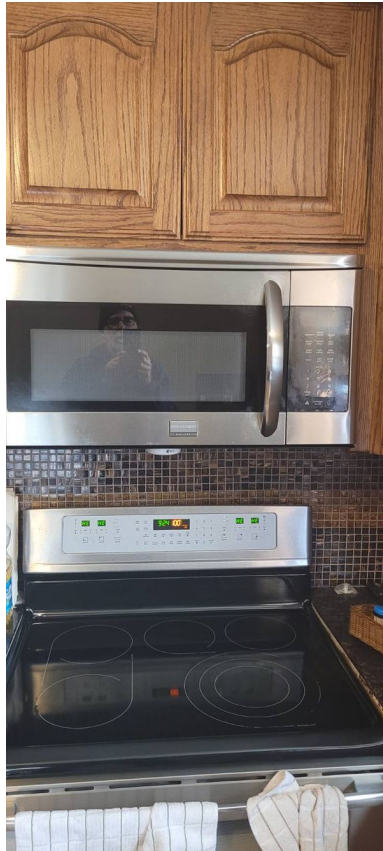
1: Inoperable

Microwave oven was inoperable at time of inspection. Recommend a qualified contractor evaluate and repair. No power to microwave

Recommendation: Contact a qualified professional.

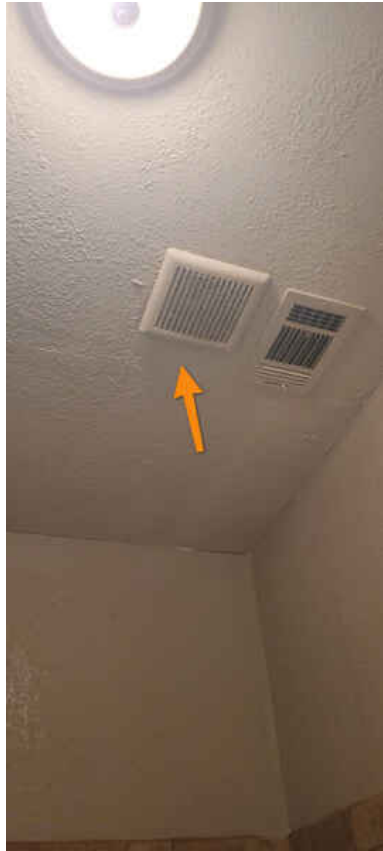
Exhaust fans need to be cleaned. Cleaning the fans regularly allows moisture to be removed from bathroom more efficiently. The purpose of the fans is to remove moisture to prevent mold.

Recommendation: Contact a qualified professional.

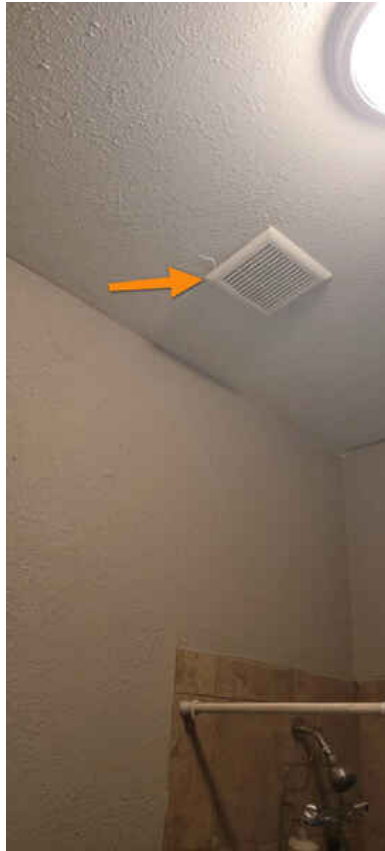
2: Exhaust fanLoose

The exhaust fan and or cover appears to be loose recommend re-securing fan to prevent further damage

Recommendation: Contact a qualified professional.
